TOWNSHIP OF NORTH STORMONT
DEMOLITION OF THE
MOOSE CREEK COMMUNITY CENTRE

RFQ 02-2022

REQUEST FOR QUOTATION

DEMOLITION OF THE MOOSECREEK COMMUNITY CENTRE

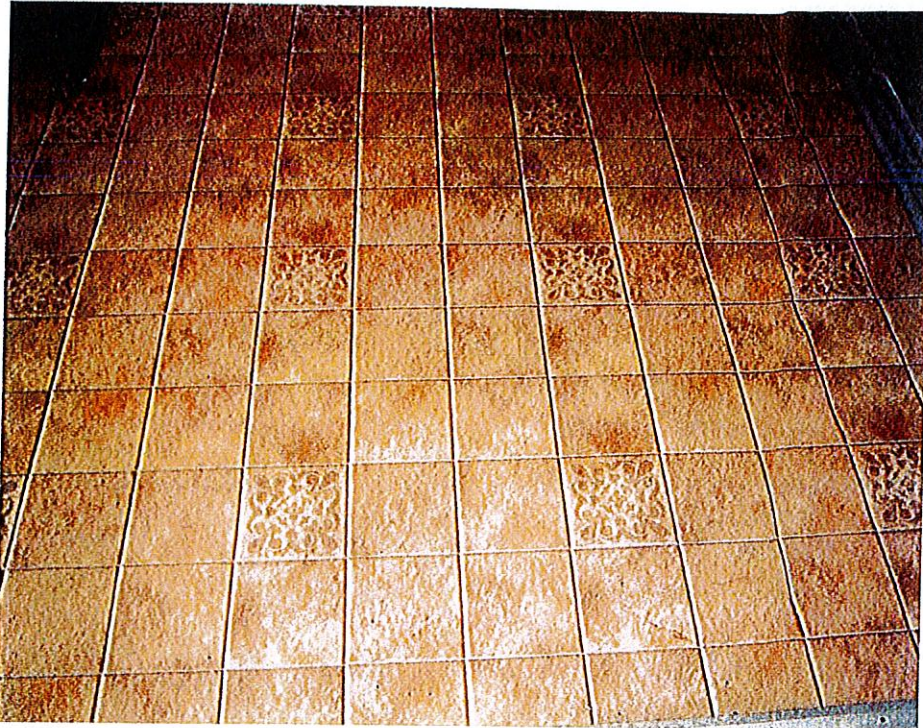
Photo 1: Location of samples S1, S2 and S3 (vinyl sheet flooring in basement) for asbestos testing. This material did not contain asbestos.

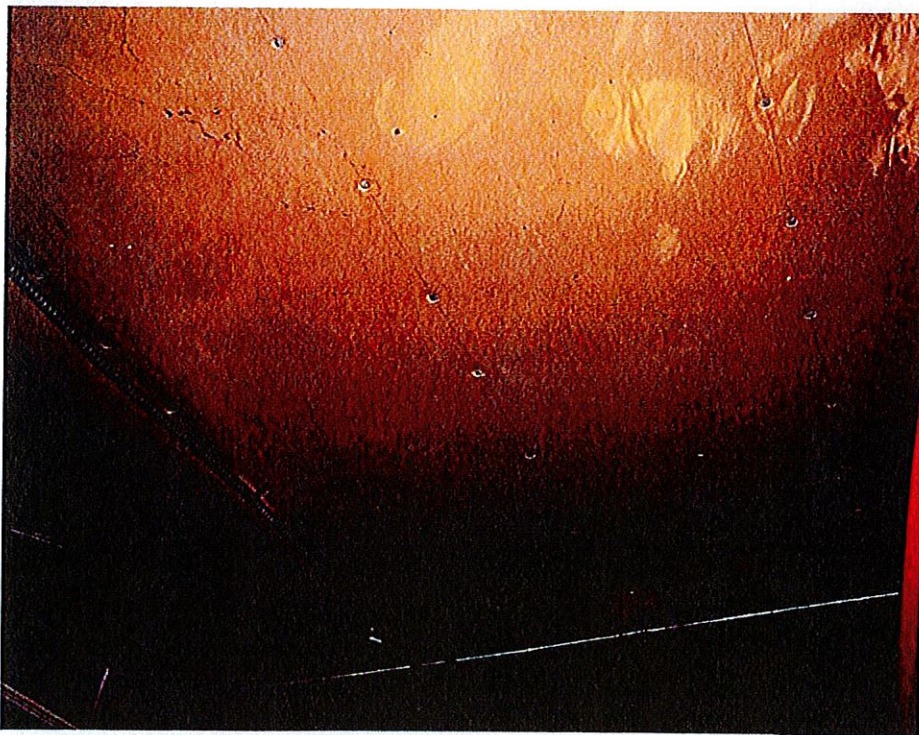
Photo 2: Location of samples S4, S5 and S6 (drywall ceiling in furnace room) for asbestos testing. This material did not contain asbestos.

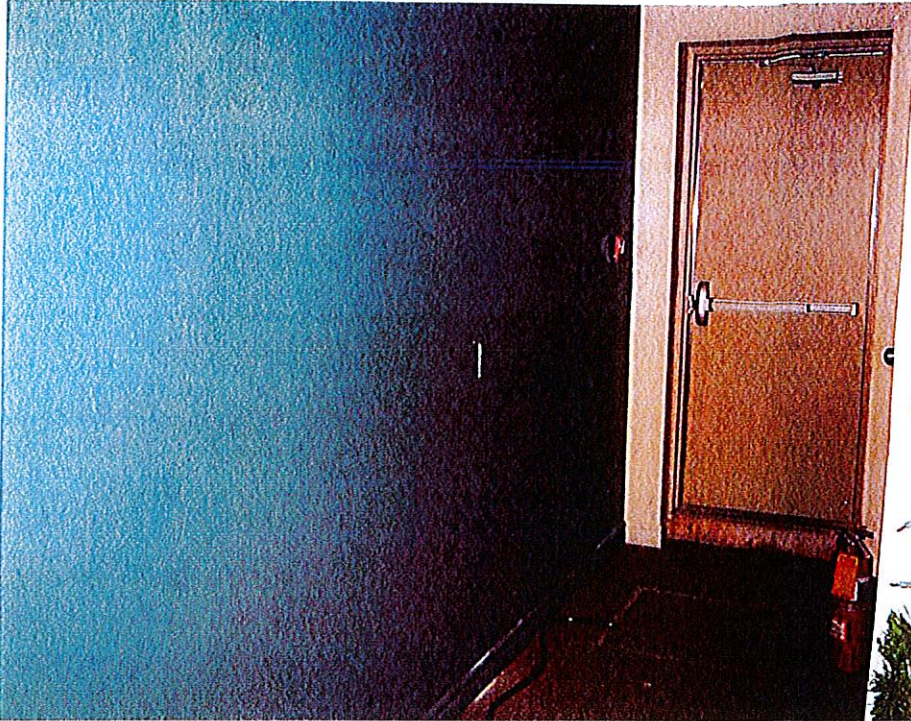
Photo 3: Location of samples S7, S8 and S9 (drywall in basement) for asbestos testing. This material did not contain asbestos.

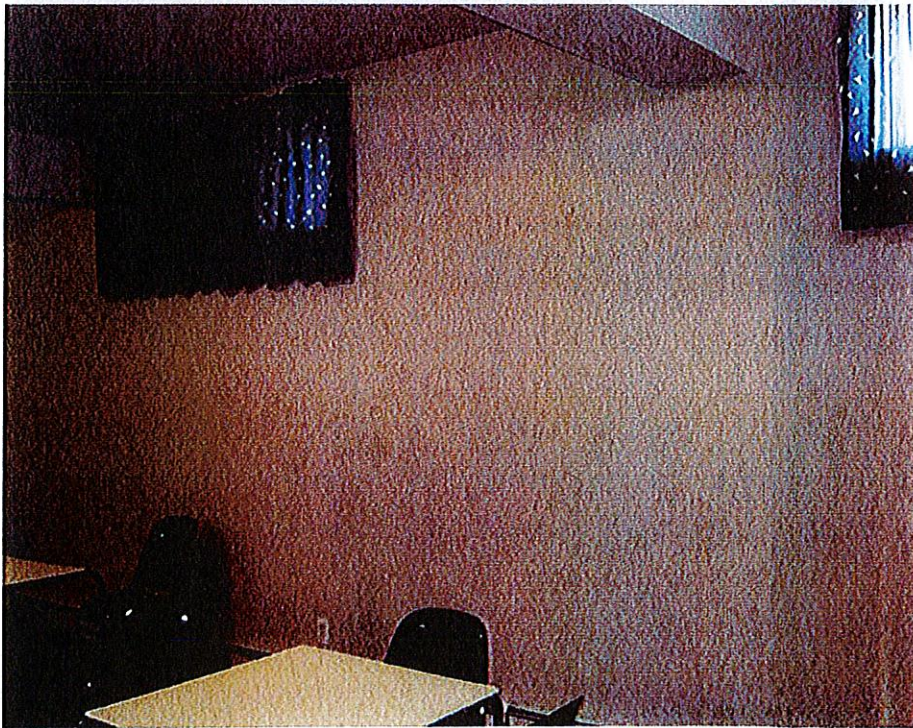
Photo 4: Location of samples S7, S8 and S9 (drywall in basement) for asbestos testing. This material did not contain asbestos.

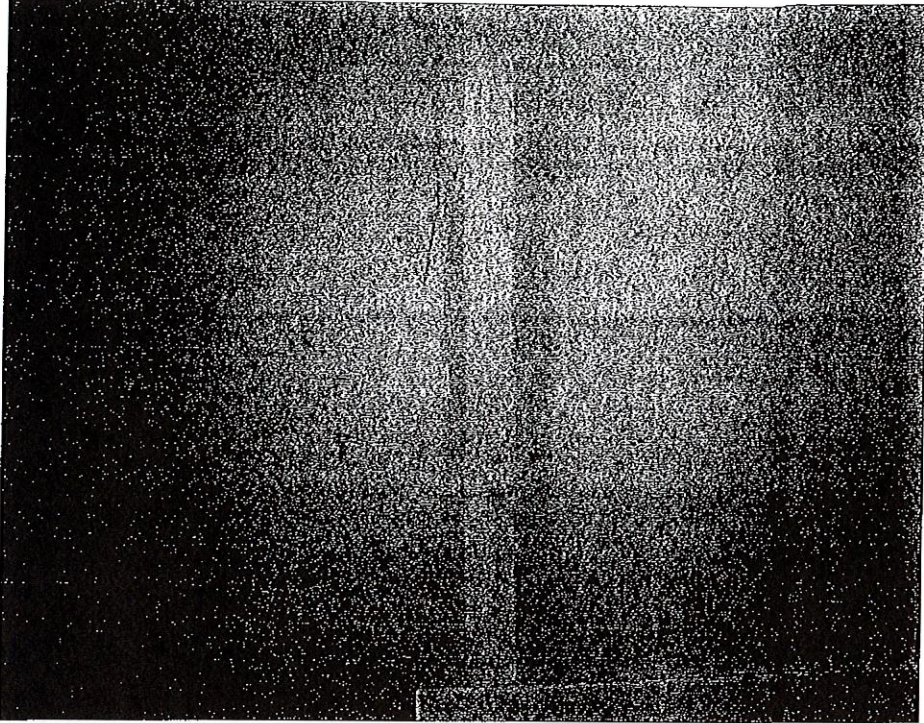
Photo 5: Location of samples S7, S8 and S9 (drywall in basement) for asbestos testing. This material did not contain asbestos.

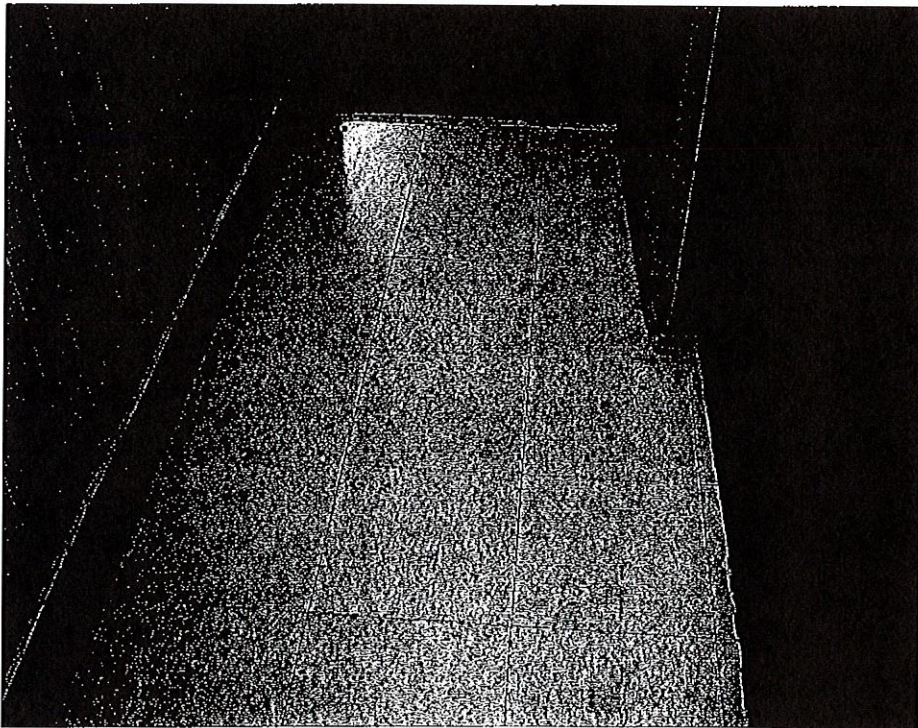
Three (3) individual samples (S10, S11 & S12) of the 12" by 12" beige coloured vinyl floor tiles found on the main floor (2nd floor) were collected. The test results determined that these tile contain 15% Chrysotile asbestos.

Photo 6: Location of samples S10, S11 and S12 (beige, floor tiles, main level, 2nd floor) for asbestos testing. These tiles were found to contain 20 to 25% Chrysotile asbestos.

- 15% Chrysotile asbestos was found in the beige coloured floor tiles on the main level (2nd floor) of the building. These tiles were found in both the men's and ladies bathrooms. It is recommended that these tiles be removed and disposed of accordingly before any demolition is performed.
- The flat portion of the roof was not sampled for asbestos at this time.
- Lead was determined to be present in both the white (6.1%) and green paint (3.7%) located in the basement. This concentration exceeds the level of 0.009% now limited for paint. However, as the painted areas are small, it is recommended that the work crew wear the required PPE (N95 dust mask, long sleeve pants and shirts) to prevent coming into contact with any lead dust that may be formed.

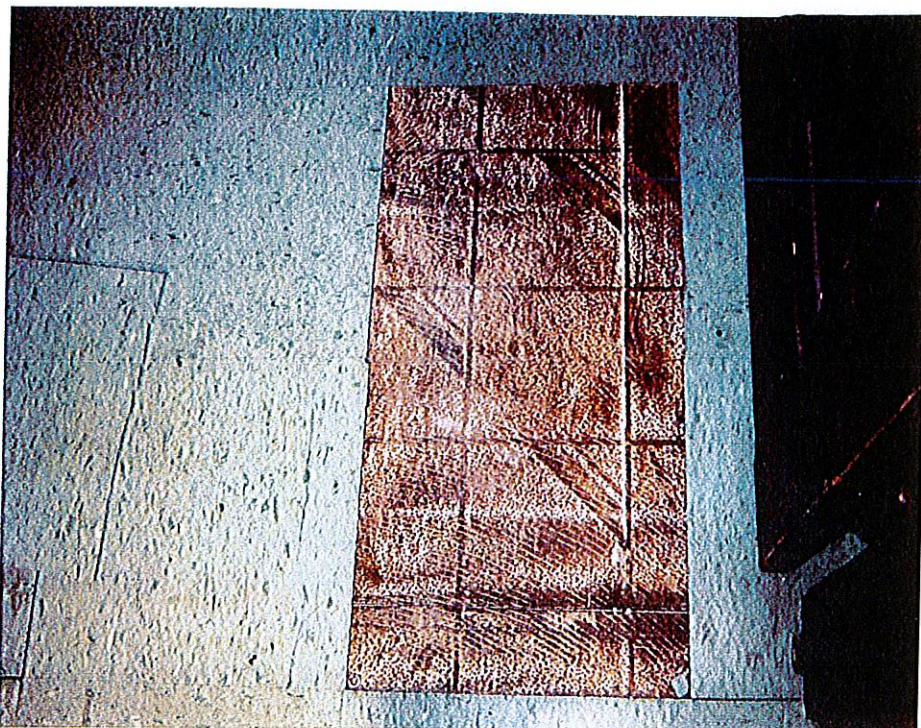
Three (3) individual samples (S13, S14 & S15) of the 12" by 12" green coloured vinyl floor tiles found on the main level (2nd floor) were collected. The test results determined that this material does not contain asbestos.

Three (3) individual samples (S28, S29 & S30) of the vinyl sheet flooring found under the green vinyl tile on the main level (2nd floor) were collected. The test results determined that this material does not contain asbestos.

Photo 7: Location of samples S13, S14 and S15 (green, floor tiles, 2nd floor) and S28, S29 & S30 (vinyl sheet flooring) for asbestos testing. This material did not contain asbestos.

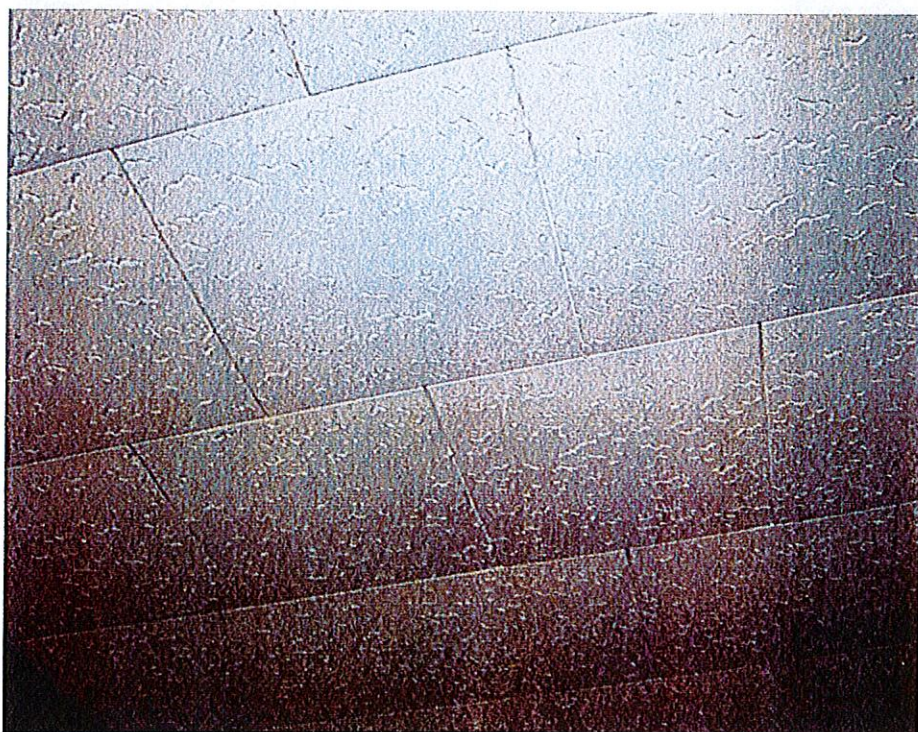
Photo 8: Location of samples S16, S17 and S18 (pin hole ceiling tiles, 2nd floor) for asbestos testing. This material did not contain asbestos.

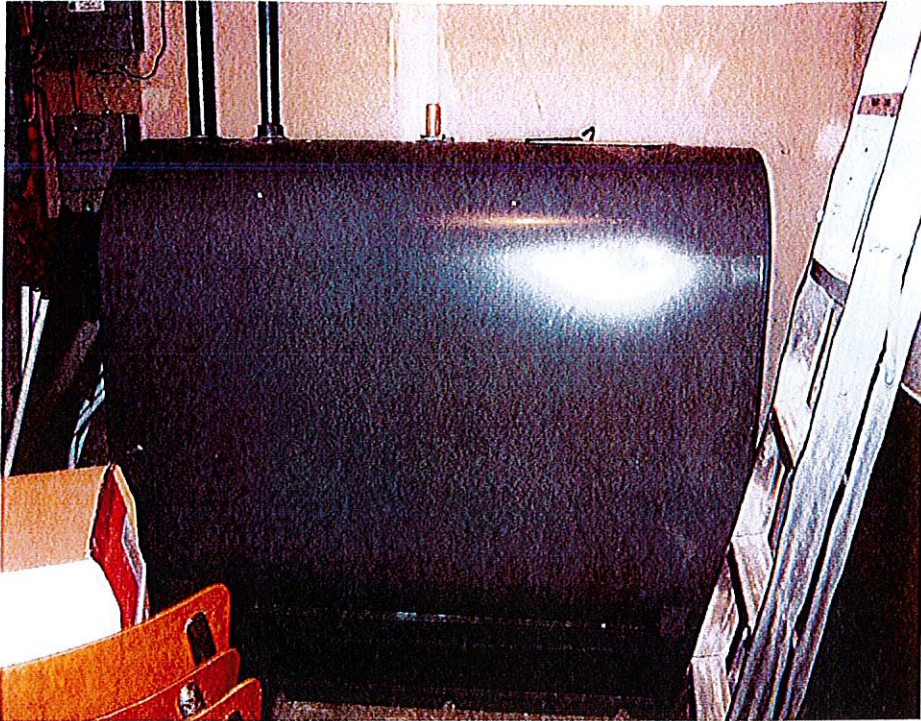
Photo 9: Heating oil tank located in the basement. Possible benzene present.

Benzene is an aromatic hydrocarbon. It is a by-product of petroleum and is commonly found in gasoline and other fuels. O. Reg. 490/09 Table 1 lists a TWA limit for benzene at 0.5 ppm. There is an above ground heating oil tank located in the basement level. It is recommended that this tank be emptied of its contents and removed prior to any demolition.

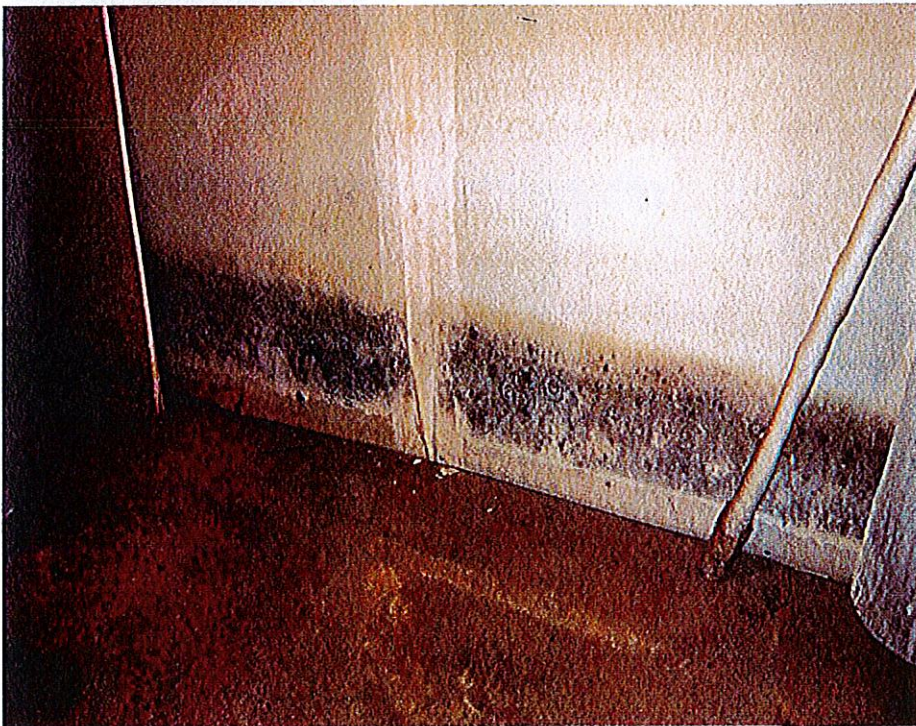
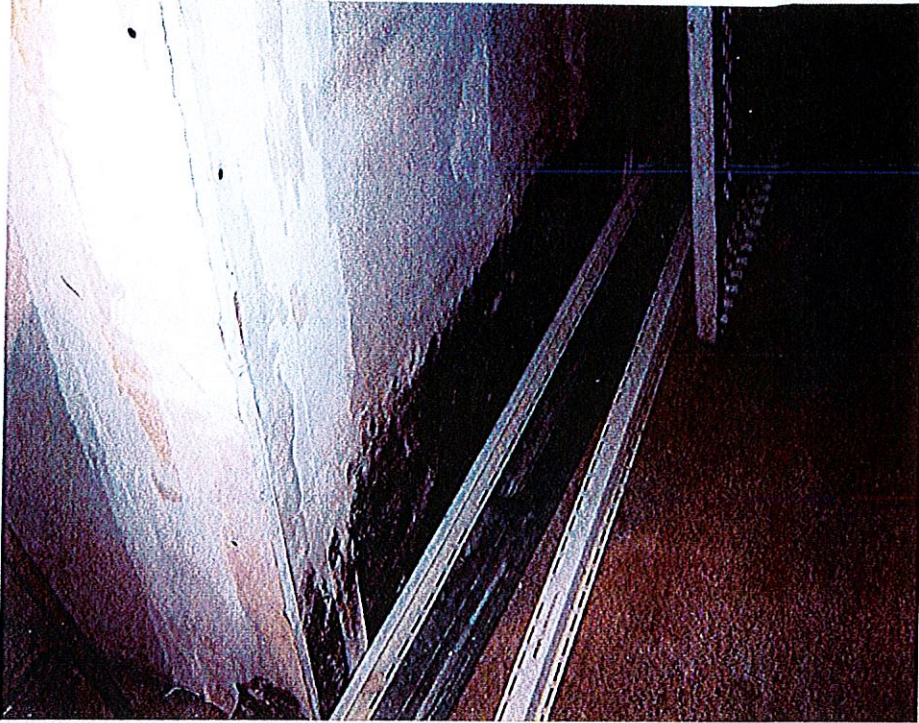
The appearance of black mould was found in the boiler room as well as the adjoining room with the above ground heating oil tank. Mould is not considered a designated substance under Ontario Regulation 490/09. If required, St. Lawrence Testing is available to sample the dark areas on the drywall for mould along with sampling the ambient air of mould spores.

Photo 10: Possible black mould found on the drywall in the basement.

Photo 11: Possible black mould found on the drywall in the basement.

- The appearance of black mould was observed in the basement. It is recommended that this be sampled along with determining the spore counts inside the building.

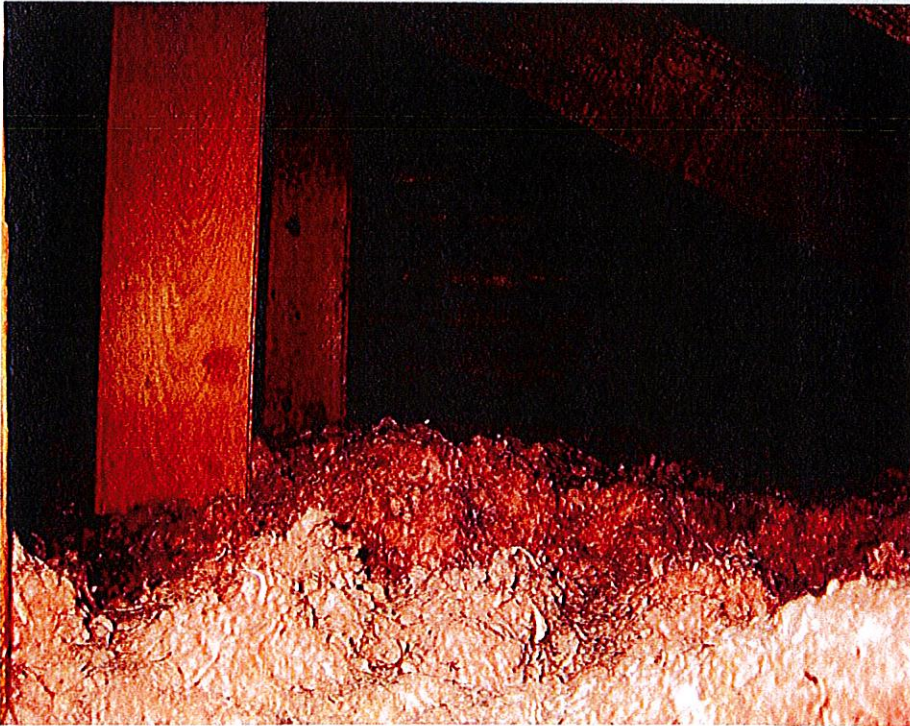
The attic space was unfinished and contained loose, fiberglass pink insulation along with a thin, paper-like material insulation between some of the roof rafters. There were more metal tiles present as well. The attic space was unlit.

Photo 12: Blown in, loose fiberglass insulation found in the attic space.

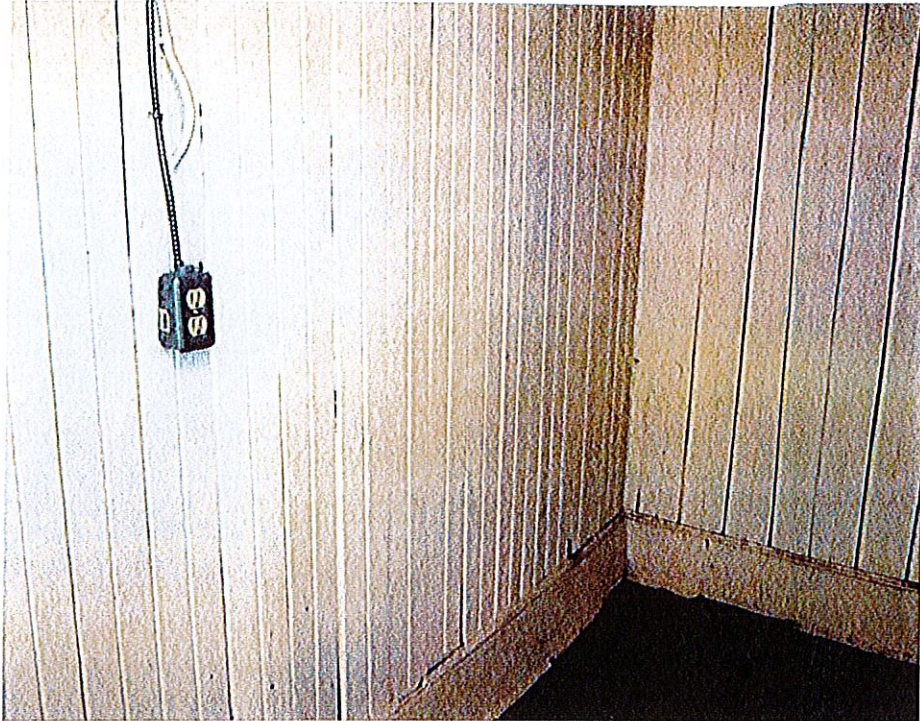
The paint samples both were found to contain a lead concentration well above 0.009%. These surfaces are considered to contain lead paint. As the area painted on the personnel door is small, it is recommended that the work crew wear the required PPE (N95 dust mask, long sleeve pants and shirts) to prevent coming into contact with any lead dust that may be formed.

Photo 13: Location of paint sample S1 (white paint on panelling in basement) for lead analysis. This paint contains 6.1% lead.

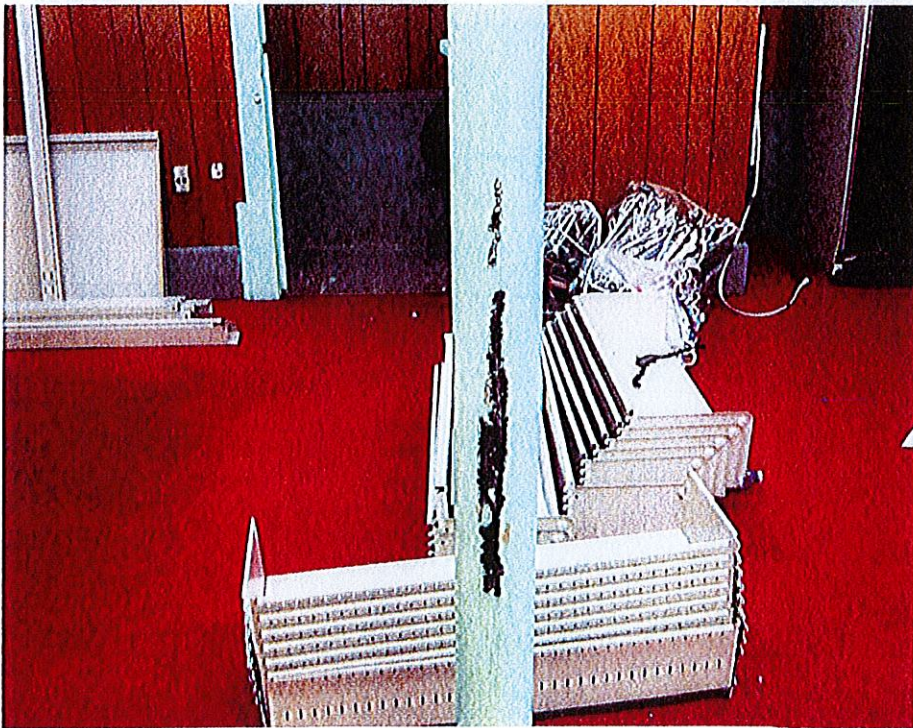
Photo 14: Location of paint sample S2 (green paint on pillar and doors in basement) for lead analysis. This paint contains 3.7% lead.

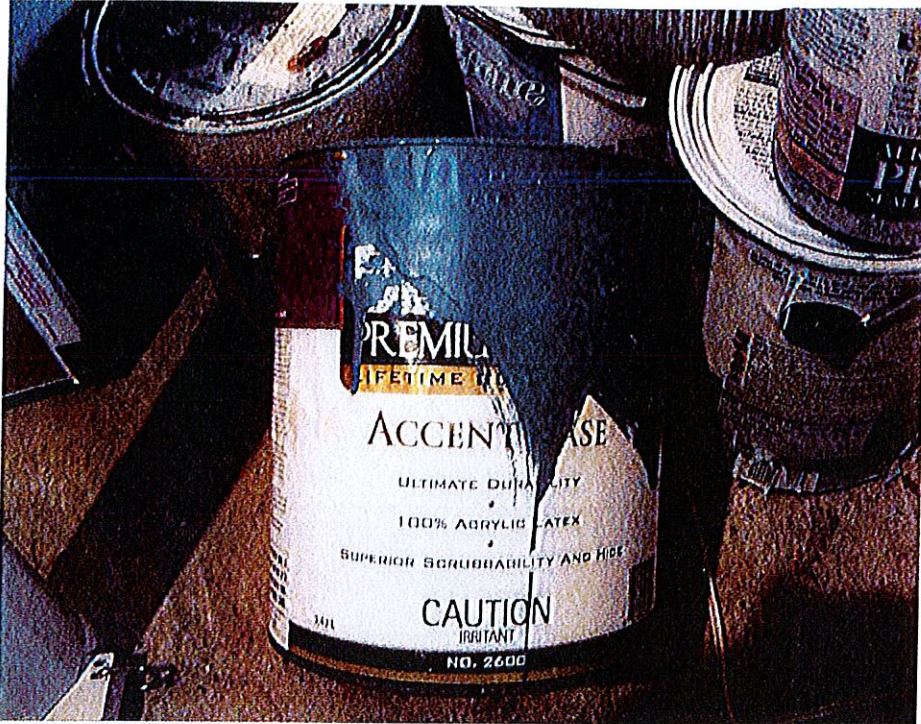
Cans of latex paint were observed in the basement level of the building. These paint colours appeared similar to some of the painted surfaces within the building. These paints would not contain lead. However, there were questionable white and green coloured painted surfaces within the basement level that were sampled for lead content.

Photo 15: Latex paints used in painting the basement walls.

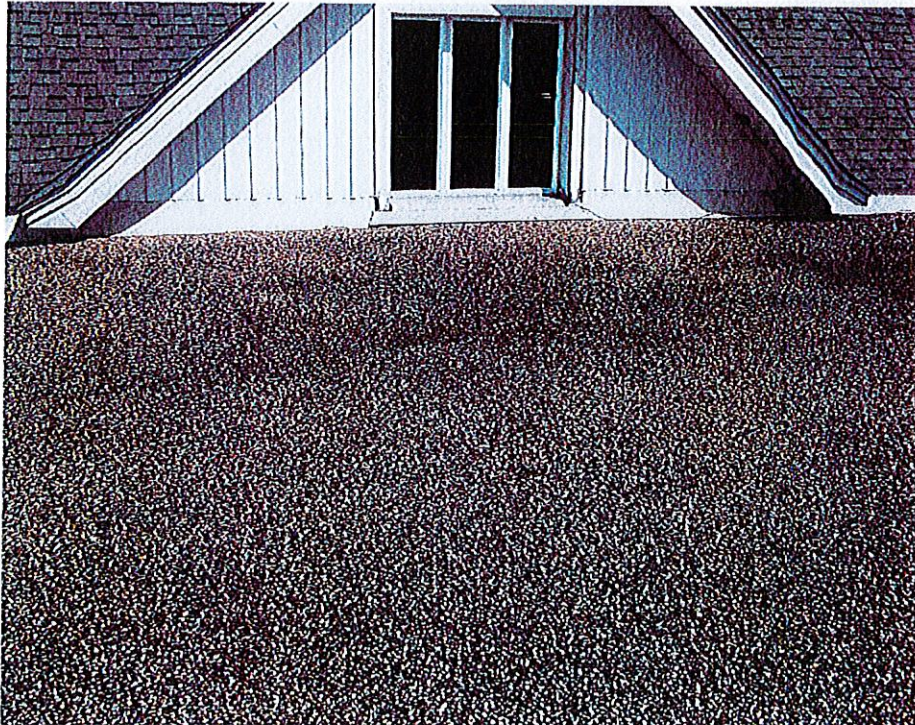
The exterior of the building was covered in brick, parging and metal siding. The peaked portion of the roof was covered in fiberglass shingles. The flat portion of the roof was covered in tar and gravel. The felt under the tar and gravel could not be sampled at this time due to possible leakage.

Photo 16: View of the tar and gravel roof (not sampled due to possible future leakage).

The flat portion of the building's roof may contain felt. This material was not sampled at the time of the assessment due to possible leakage into the building. It is recommended that this material be tested for asbestos after the building is closed and no longer being occupied.
