**Environmental Impact Study (EIS)
&
Headwater Assessment**

Valley Street

**Part Lot 18, Concession 7
Township of North Stormont
United Counties of Stormont, Dundas and Glengarry**

July 2022

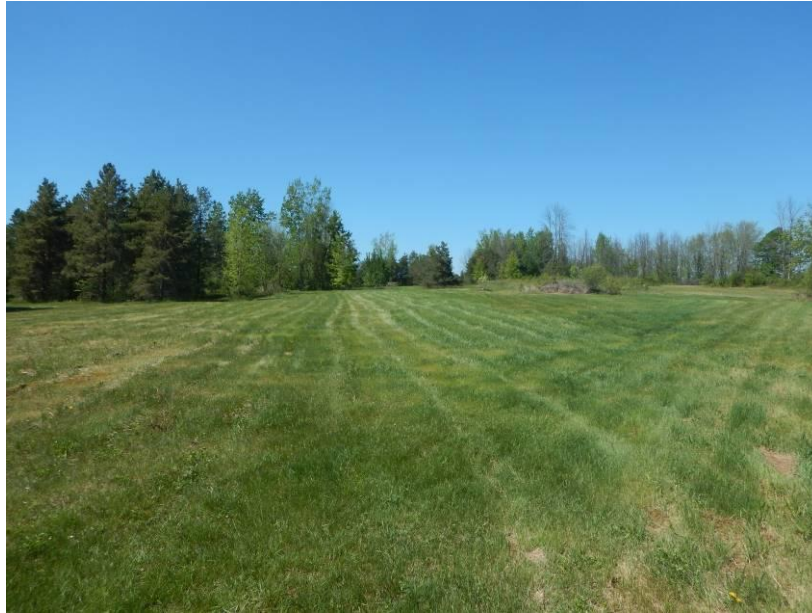
This meadow was present throughout the subject lands. This area was regularly mowed, and kept at a height no greater than 10cm (indicated by the proponent). Ground cover (100%) was dominated by grasses, goldenrods, common ragweed, and cow vetch. Individual and clump of trees and shrubs were present throughout (ash, scot's pine, white cedar and common buckthorn). Some portions included rows of planted pine.

Photo 1: Cultural Meadow (May 18, 2022)

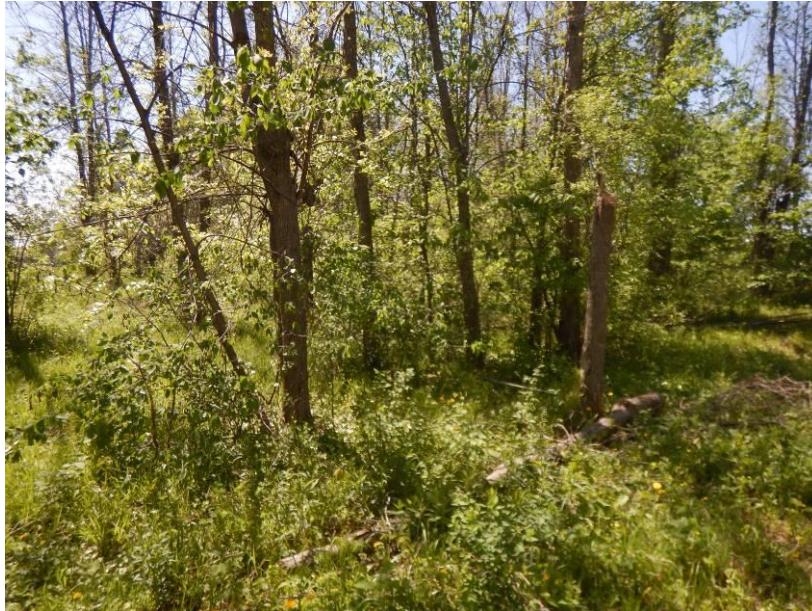
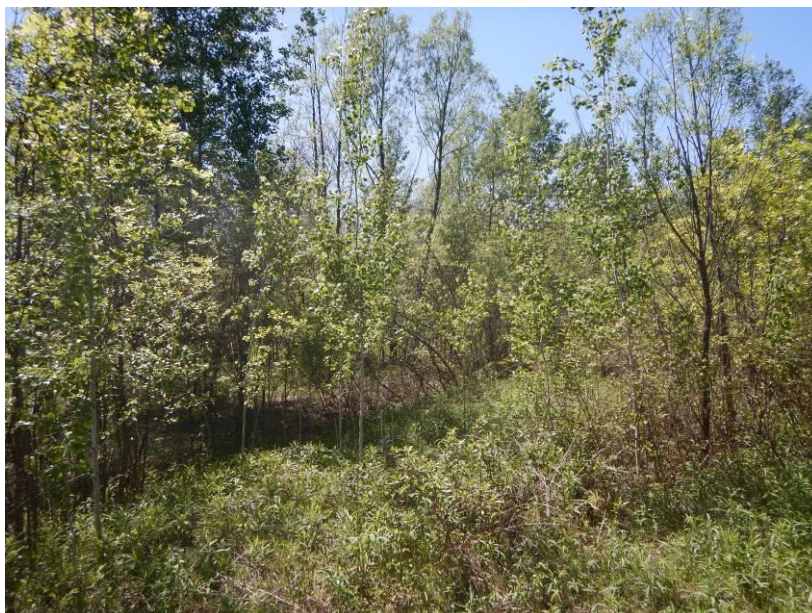
The forest was present throughout the central and southern areas of the subject lands. The average tree diameter was highly variable with a range of 5-25cm DBH. The canopy was the dominant layer within most of the location. Some areas contained a high amount of dead ash within these areas the sub-canopy and understory where overdeveloped and dominate. The canopy (12m tall; 85% cover) was dominated almost equally by trembling aspen and white ash (lots of dead) with the occasional butternut. The sub-canopy (8m tall; 60% cover) consisted of trembling aspen and white ash. The understory (1-4m tall; 80% cover) was dominated by alternate-leaved dogwood followed by nannyberry and American elm. The ground layer provided 20% cover with common species including Canada enchanter's nightshade, horsetail, common strawberry, and Virginia Creeper. Within the southern portion of this community there is evidence of past clearing activity and an access road/trail. Along some portions of this road/trail there are depression areas on each side containing willows.

Photo 2: Dry-Fresh Deciduous Forest (May 18, 2022)

Photo 3: Dry-Fresh Deciduous Forest (May 18, 2022)

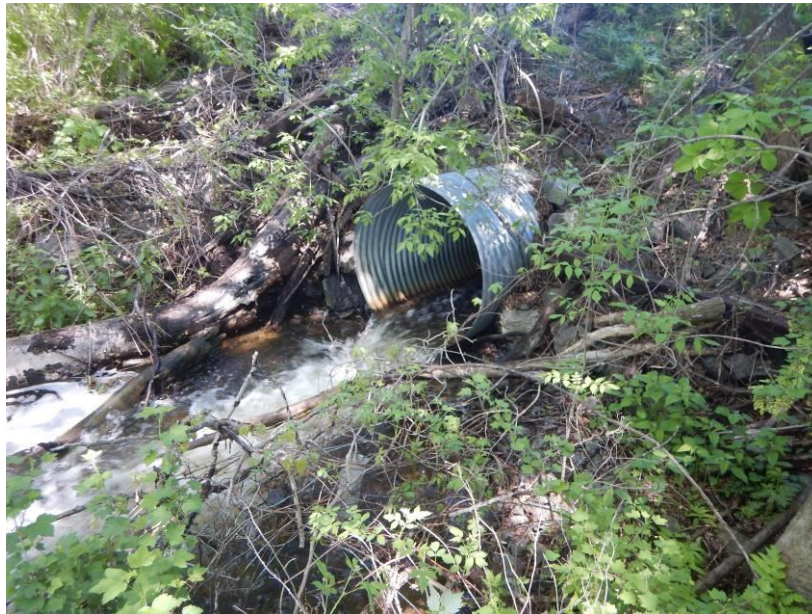
roadside, disturbed area, and mowed lawn. At the downstream end, the tributary enters Angus Grant Municipal Drain before entering a culvert and passes under the railroad tracks, continuing offsite. During the May 18, and June 13th, 2022 site visit the culvert downstream of the tracks was perched 10cm in the air, representing an upstream barrier to fish movement. Fish were observed in schools downstream of the above mentioned culvert. The Angus Grant Municipal Drain eventually flows into Moose Creek. The entire tributary within the subject lands was man-made and confined with a straight pattern, with a large portion consisting of roadside ditch. Multiple culvert crossings were noted throughout. Three sampling sites were established within the tributary. Site 1 and 3 on the main branch and Site 2 on a small side branch.

Photo 4: Perched Culvert Downstream of Tracks (May 18, 2022)

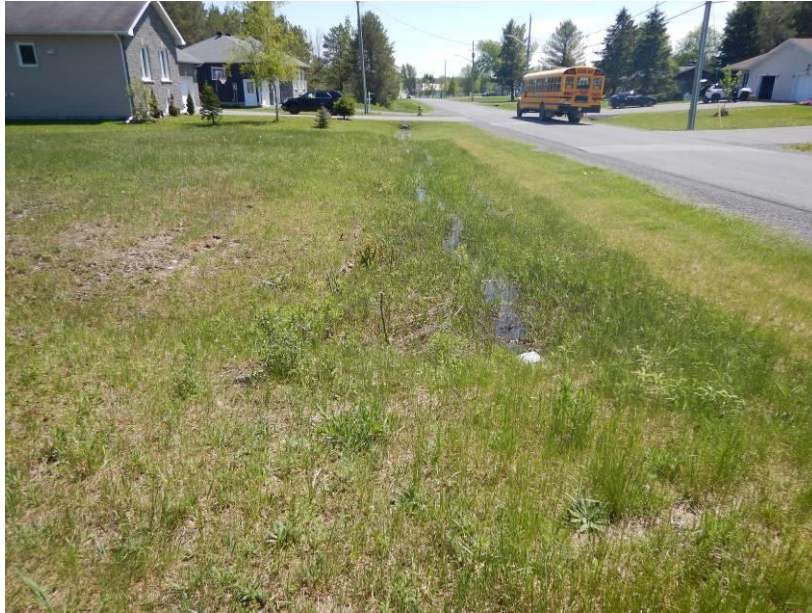
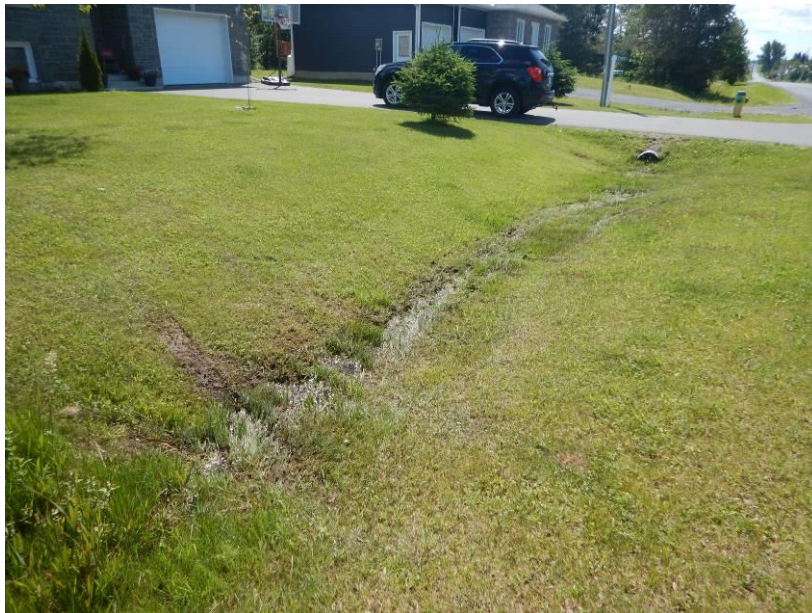
A man-made tributary to Angus Grant Municipal Drain was located within the subject lands. This tributary originates at the north end of the subject lands at a large man-made pond and flows towards the south end of the subject lands. The outlet of this pond where water can exit and flow downstream into the tributary is piped. Therefore, the water discharge is currently being controlled. Within the subject lands the tributary travels through different types of riparian habitat including: forest, meadow,

Photo 5: Portions of the Tributary Running along Valley Road (May 18, 2022)

Photo 6: Portions of the Tributary Running along Valley Road - Dry (June 13, 2022)

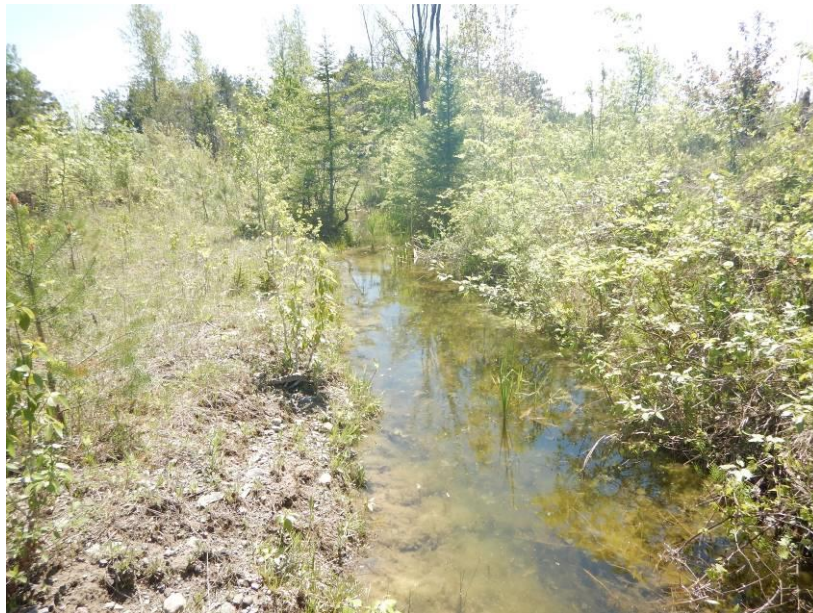
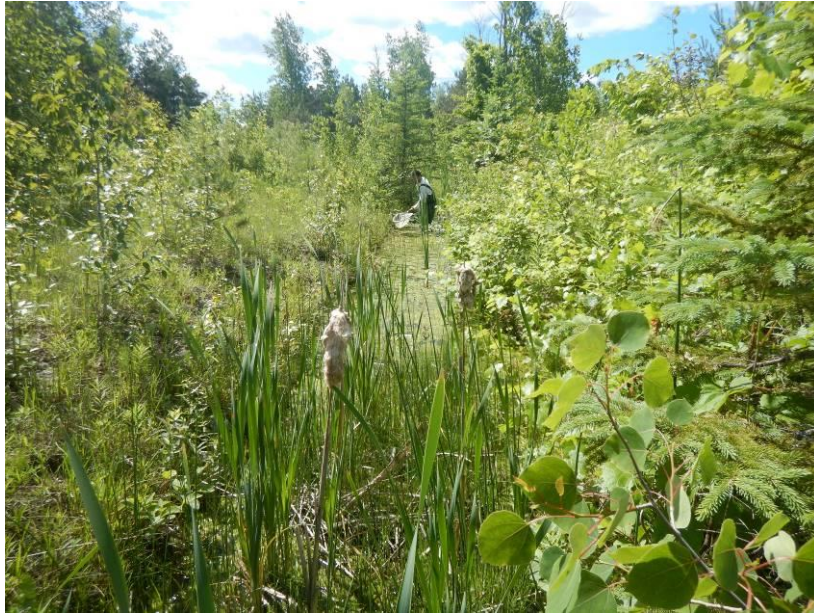
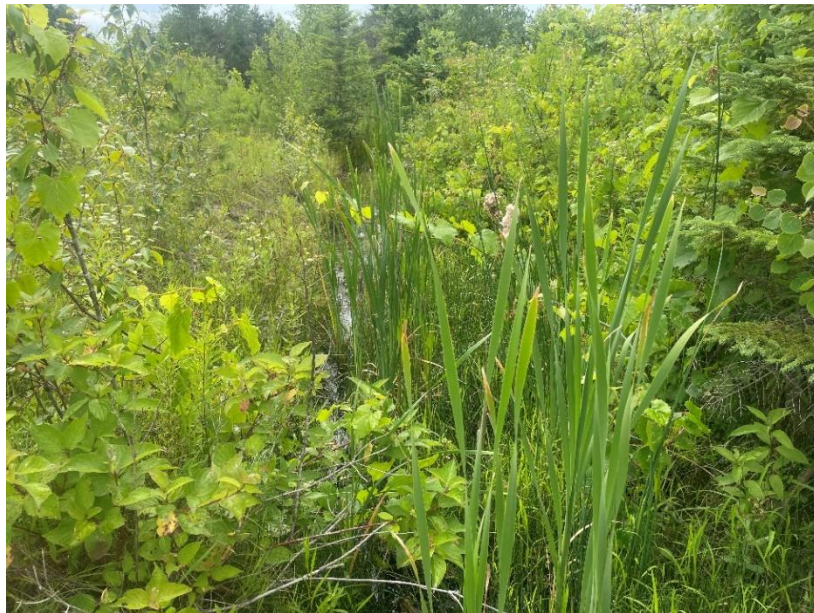
This site was established approximately 90m downstream of the man-made pond. It is located within meadow riparian habitat along the western banks and disturbed/residential land with an access road along the eastern bank. Site 1 was approximately 43m in length and flows in a southern direction. The average channel width was 2.2m and the average bankfull height 30cm. The substrate consisted of fines. The in-water cover consisted entirely of aquatic vegetation which included: narrowleaf cattail, purple

loosestrife and horsetail. The canopy cover ranged from poor to moderate, with 100% bank vegetation throughout the site. The most common species were: trembling aspen, white spruce, balsam poplar, Bebb's willow, alternate-leaved dogwood, grasses, cow vetch, and goldenrods. No signs of erosion were noted.

During the May 18, 2022 visit, the average wetted width and water depth was 1.6m and 9cm (range: 1-54cm), respectively. The hydrological flow habitat consisted mostly of glide, with a small section of run habitat at the upstream end and a pooled area towards the downstream end.

During the June 13, 2022 visit, the average wetted width and water depth was 1.3m and 6cm (range: 1-14cm), respectively. The hydrological flow habitat consisted of standing water (downstream portions of the tributary was dry). The site was sampled for fish during the June 13, 2022 visit using a dip net (100+ dips). One brown bullhead was captured within the pooled area at the downstream end of the station. Although one fish was present (due to the pond) it is this authors opinions that this site should not be considered fish habitat.

During the July 5, 2022 visit, the average wetted width and water depth was 1.4m and 7cm (range: 2-25cm), respectively. The hydrological flow habitat consisted of standing water (downstream portions of the tributary was dry).

Photo 7: Site 1 Looking Downstream from Upstream (May 18, 2022)

Photo 8: Site 1 Looking Downstream from Upstream (June 13, 2022)

Photo 9: Site 1 Looking Downstream from Upstream (July 5, 2022)

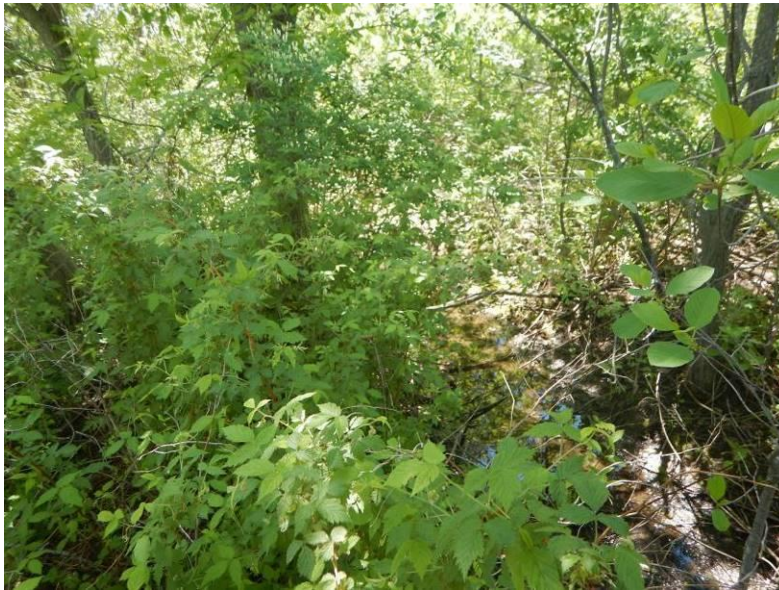
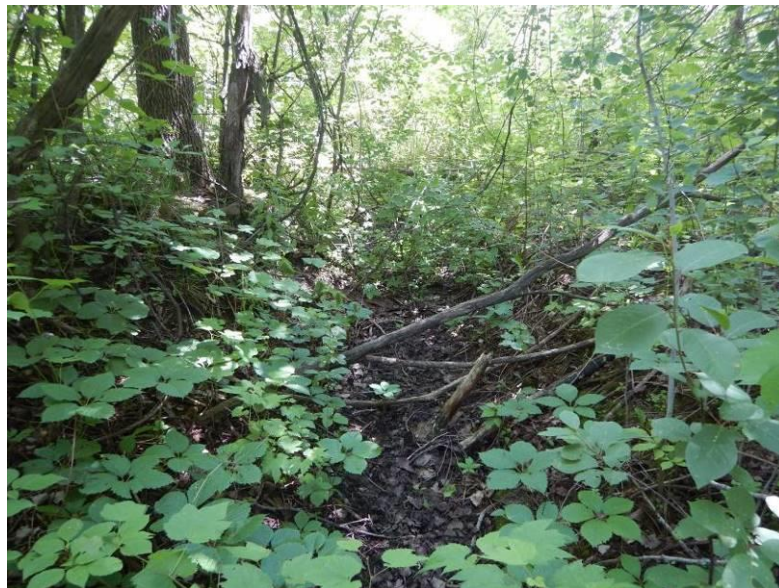
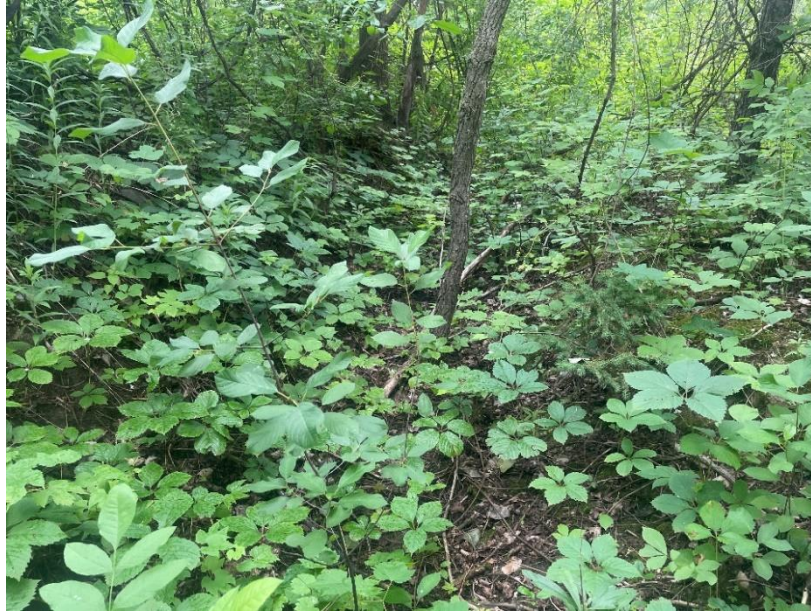
This site was established approximately 180m downstream of the man-made pond. It is located within forest habitat along a side branch. Site 2 was approximately 40m in length and flows in a westerly direction. The average channel width was 1.3m and the average bankfull height 20cm. The substrate consisted of fines. The in-water cover consisted of areas of small woody debris. The canopy within the site contained full cover, with 100% bank vegetation. The most common species were: white ash,

American elm, trembling aspen, alternate-leaved dogwood, Tartarian honeysuckle, wild red raspberry, grasses, common strawberry, and goldenrod. No signs of erosion were noted.

During the May 18, 2022 visit, the average wetted width and water depth was 0.6m and 2cm (range: 1-7cm), respectively. The hydrological flow habitat consisted of standing water (downstream portions were dry).

During the June 13 and July 5, 2022 visit, the entire site was dry. This site was not sampled for fish due to a lack of water. This site should not be considered fish habitat.

Photo 10: Site 2 Looking Upstream from Downstream (May 18, 2022)

Photo 11: Site 2 Looking Upstream from Downstream (June 13, 2022)

Photo 12: Site 2 Looking Upstream from Downstream (July 5, 2022)

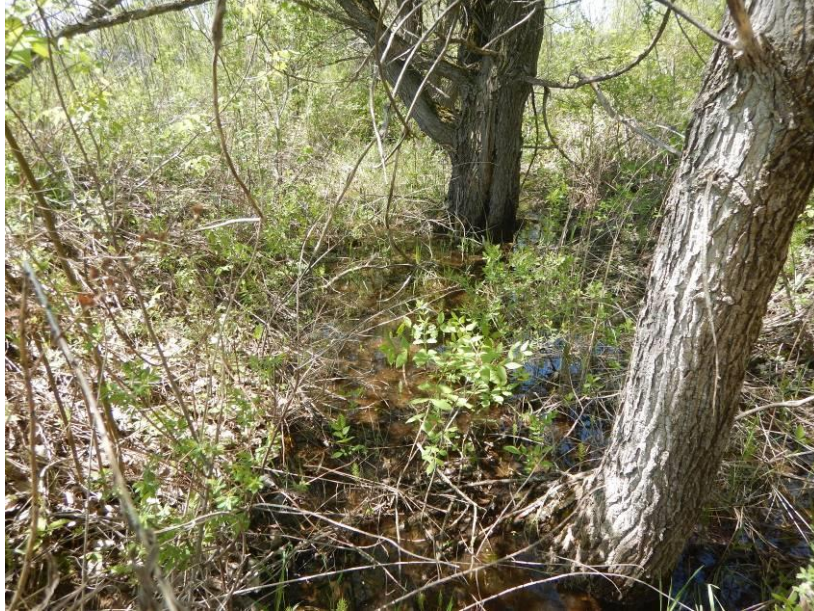
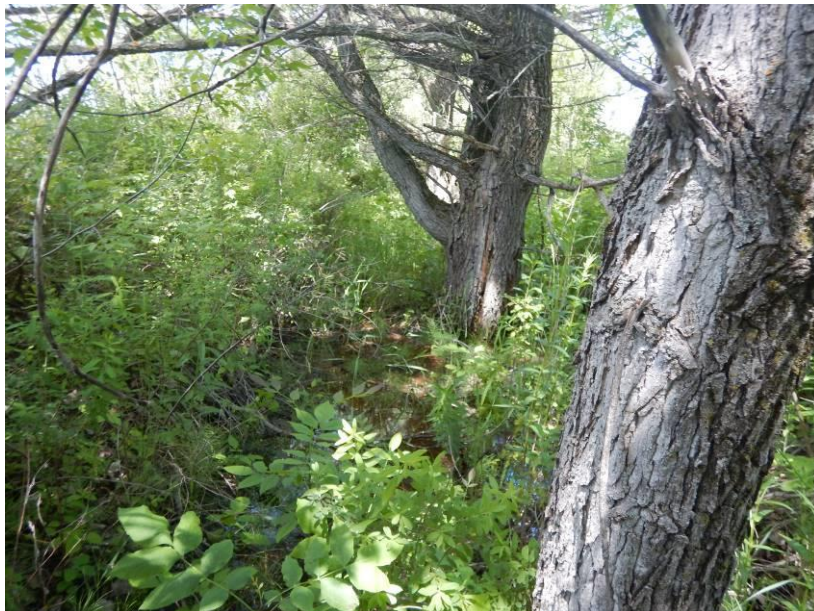
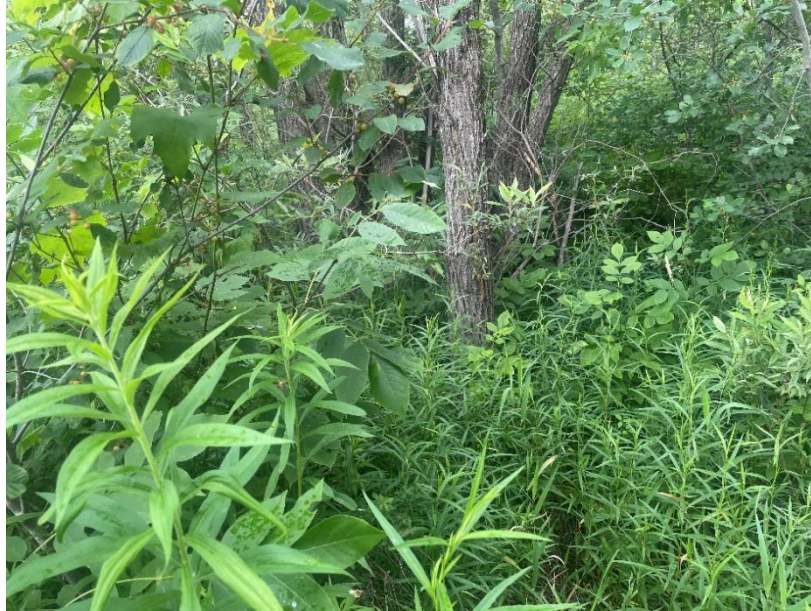
Site 3 was established approximately 630m downstream of the man-made pond. It is located within forest and meadow habitat. Site 3 was approximately 70m in length and flows in a southeast direction. The average channel width was 4m and the average bankfull height 29cm. The substrate consisted of fines. The in-water cover consisted entirely of aquatic vegetation which included: narrowleaf cattail, purple loosestrife and horsetail. The canopy within the station contained full cover, with 100% bank vegetation. The most common species were: black willow, white ash, American elm, cottonwood, alternate-leaved dogwood, red-osier dogwood, grasses, cow vetch, and goldenrod. No signs of erosion were noted.

During the May 18, 2022 visit, the average wetted width and water depth was 3.3m and 7cm (range: 2-14cm), respectively. The hydrological flow habitat consisted of glide.

During the June 13, 2022 visit, the average wetted width and water depth was 1.1m and 2cm (range: 1-6cm), respectively. The hydrological flow habitat consisted of standing water (upstream and downstream portions where dry). The station was sampled for fish during the June 13, 2022 visit using a dip net (100+ dips). No fish were captured or observed. This site should not be considered fish habitat.

During the July 5, 2022 visit, the station was dry.

Photo 13: Site 3 Looking Upstream from Downstream (May 18, 2022)

Photo 14: Site 3 Looking Upstream from Downstream (June 13, 2022)

Photo 15: Site 3 Looking Upstream from Downstream (July 5, 2022)

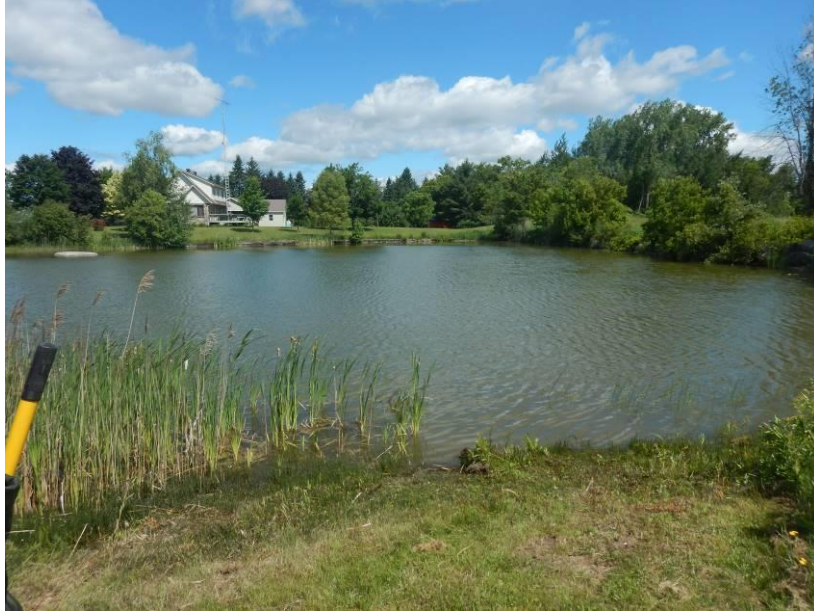
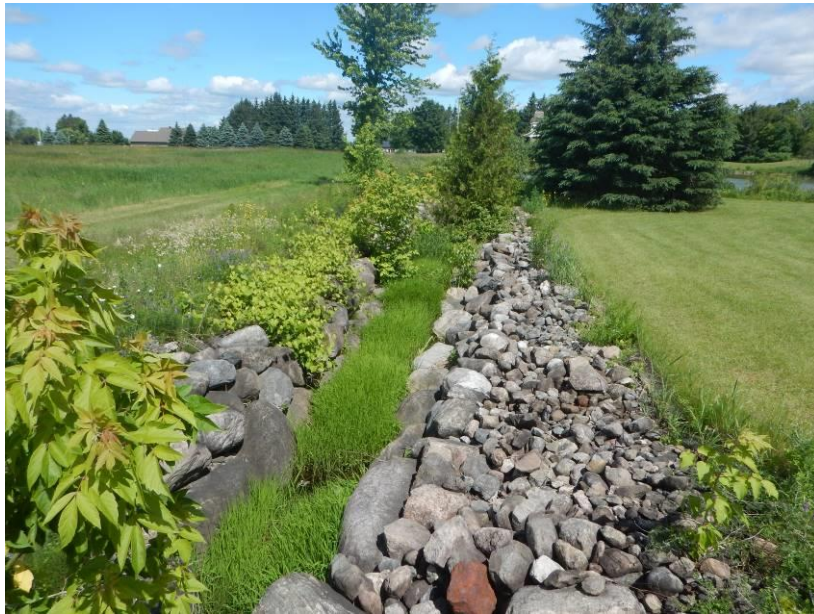
This man-made pond, located at the upstream end of the tributary, was approximately 77mx55m in size. As previously mentioned, there is an outlet at the southwest corner in which water can exit the pond through a pipe and continue into the tributary. The banks surrounding the pond consisted of meadow, manicured lawn, residential, and agricultural land. There is a gradual drop moving towards the center of the pond with depths greater than 2m. During the June 13, 2022 visit, the pond was sampled using a seine net to determine the presence or absence of fish. After a total of 5 seine net pulls, approximately 350-400 fish were captured representing 5 species: rock bass, creek chub, brown bullhead, finescale dace, and fathead minnow. Koi were also observed within the pond (observed jumping). This pond represents fish habitat. The proponent has indicated that all fish within the pond have been added by people over the year. Either purchases to purposely add to the pond or by dumping bait buckets. The ponds outlet is capped in the spring, water is only present within the pond because of this. The presence of koi is problematic they should not be allowed to escape the pond. This is not a natural system.

Photo 16: Pond (June 13, 2022)

Photo 17: Pond Outlet (June 13, 2022)
